**Inspection Report**  
Sample Report

**Specialty Building  
Consultants, LLC**

**Address:** 123 Main St, Birmingham, AL 35080

<b>Date:</b> 8/24/2016	<b>Time:</b> 02:30 PM	<b>Report ID:</b> 08242016-1
<b>Property:</b> 123 Main St Birmingham AL 35080	<b>Customer:</b> Sample Report	<b>Real Estate Professional:</b>

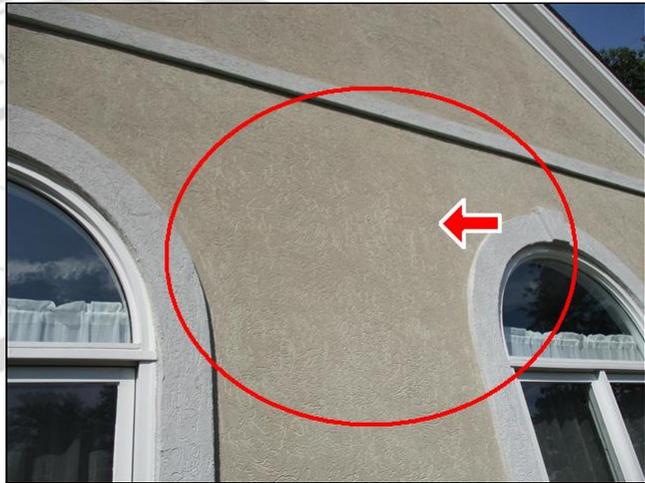
1.0 Item 9(Picture)

1.0 (2) The finish coat on the front elevation has faded due to the amount of sun the home receives.

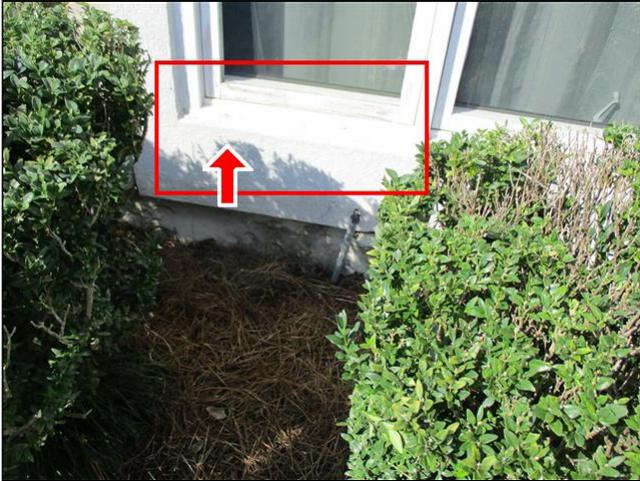
1.3 Item 1(Picture)

**1.3** Sealants around windows need repair. This will involve removal of failed sealants, cleaning of the joints and replacement with new sealants (caulks)

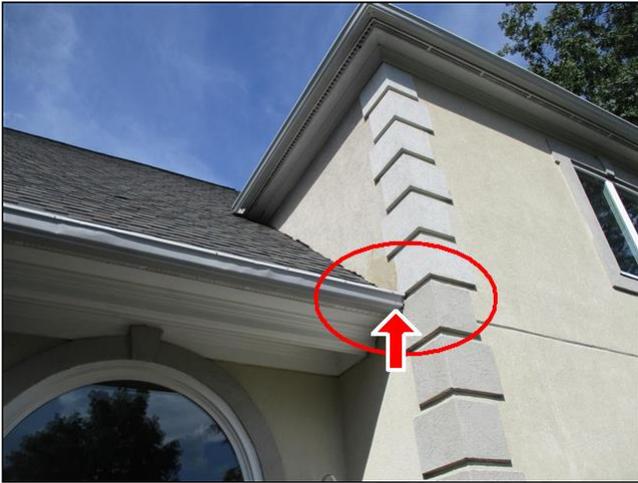
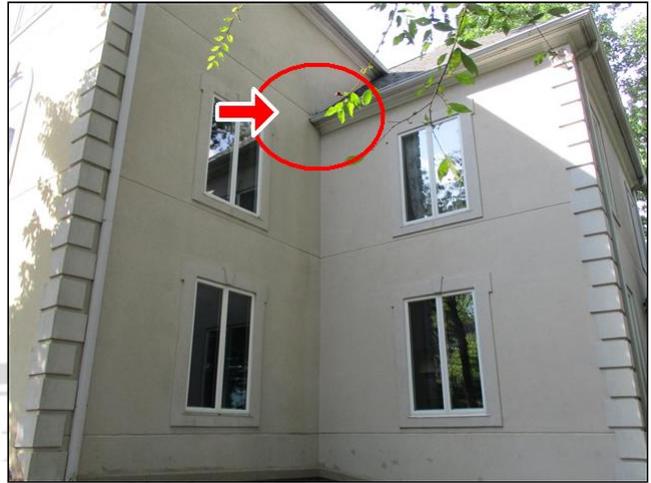
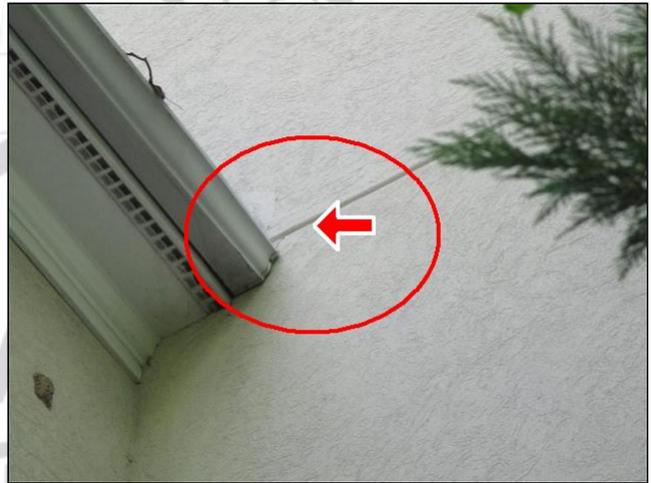
**1.7** The improper kick-out / roof terminations need to have a proper flashing installed or the current flashing modified or replaced and sealed to prevent water intrusion through the system at these areas. During the installation of any flashing the immediate area can be inspected for wood rot or damage. Any other roof flashing in the area should also be checked as they sometimes can be a contributing cause. We suggest that the sidewall flashings of the roof be set in roof cement in the areas of kickouts as a preventative measures. These areas need to be addressed.

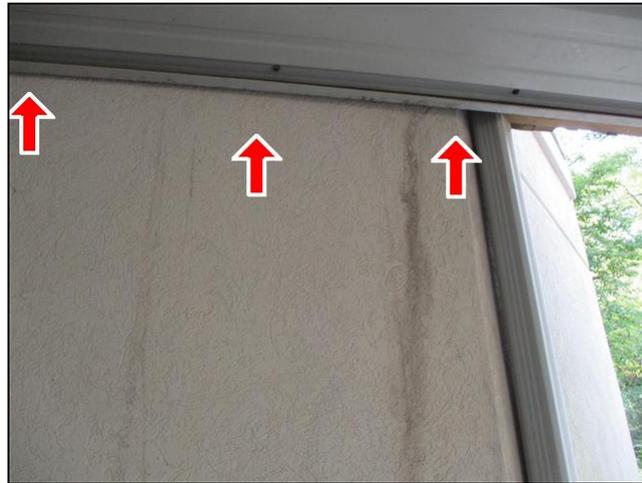
1.8 Item 1(Picture)

**1.8** The deck installation where it is attached to the house is not done properly. Decks are a very vulnerable area for moisture entry. There is a special flashing configuration that is required for this area.

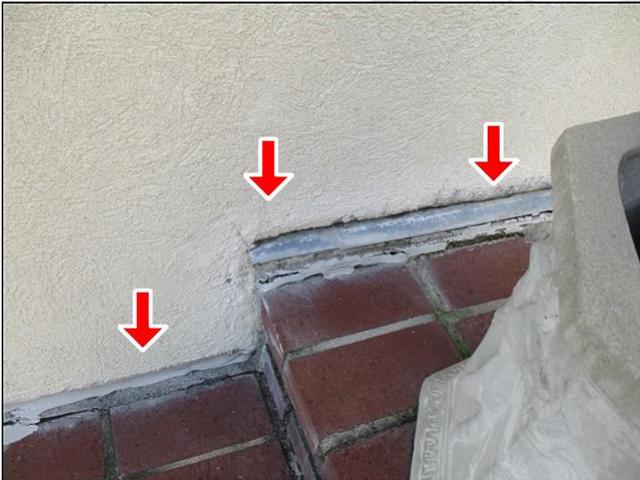
1.9 Item 7(Picture)

**1.9 (2)** The EIFS should be terminated above the porch or stoop. We can not comment about the condition of the EIFS where it is not exposed. If cutting the EIFS back is not an option, then sealing this joint is necessary.

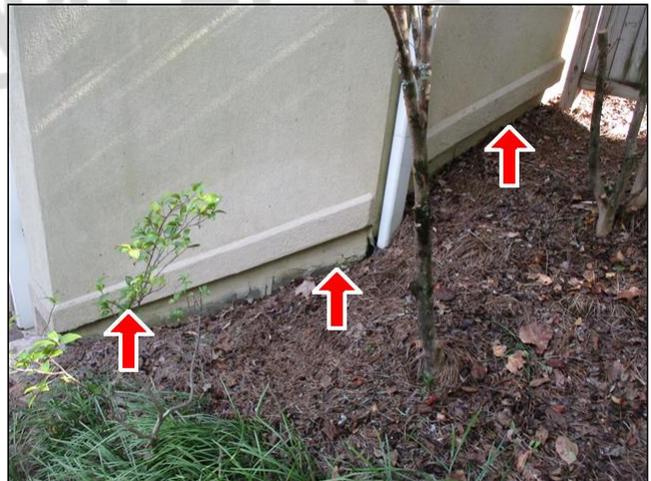
1.14 Item 2(Picture)

**1.14** The EIF system does terminate above grade.

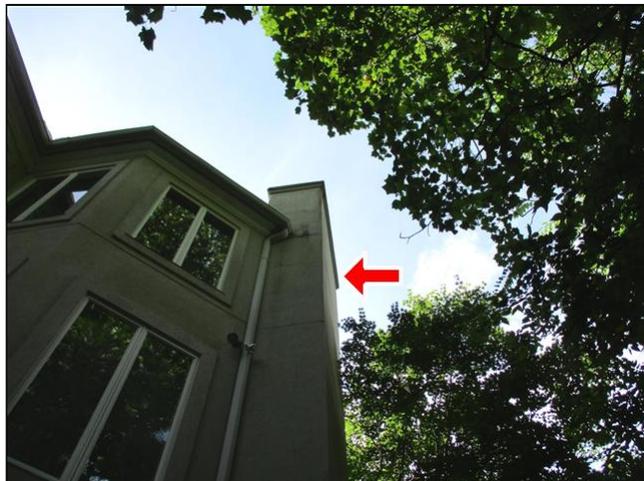
1.15 Item 1(Picture)

**1.15** Chimney has a hard coat system installed. The system has several large visible cracks that are in need of sealing.

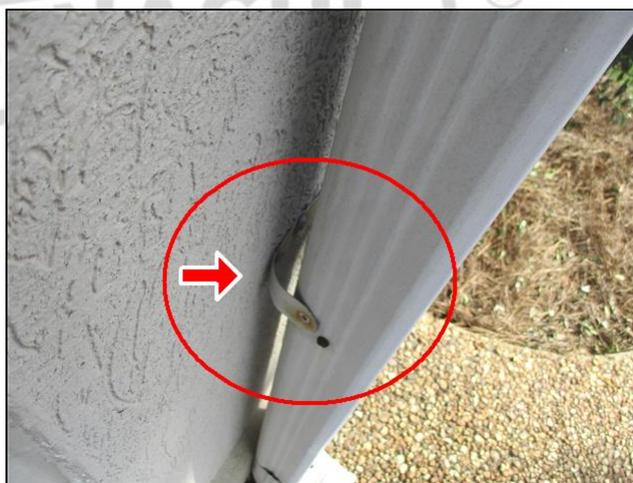
1.17 Item 1(Picture)

**1.17** The downspout fasteners should be sealed to prevent water entry.

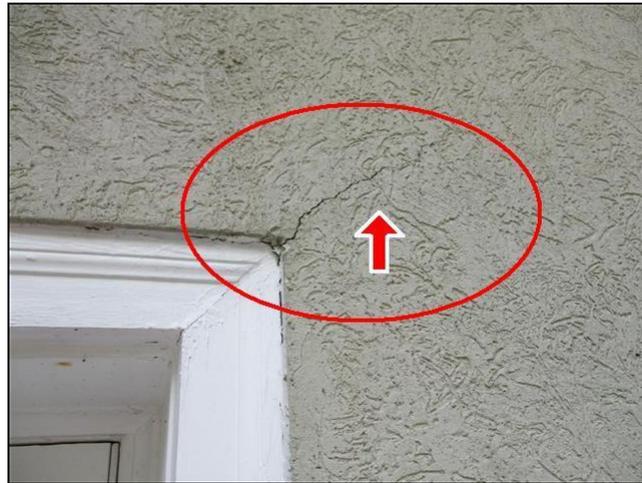
1.18 Item 1(Picture)

**1.18** There were some cracks found in the system in a few areas - more may be present. These cracks need to be sealed to protect the integrity of the system.

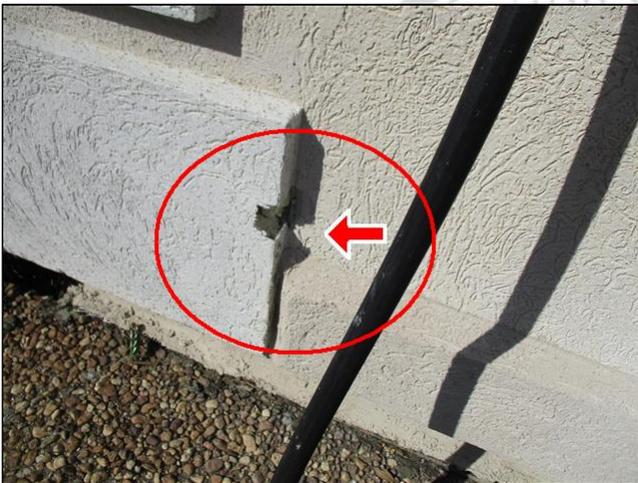
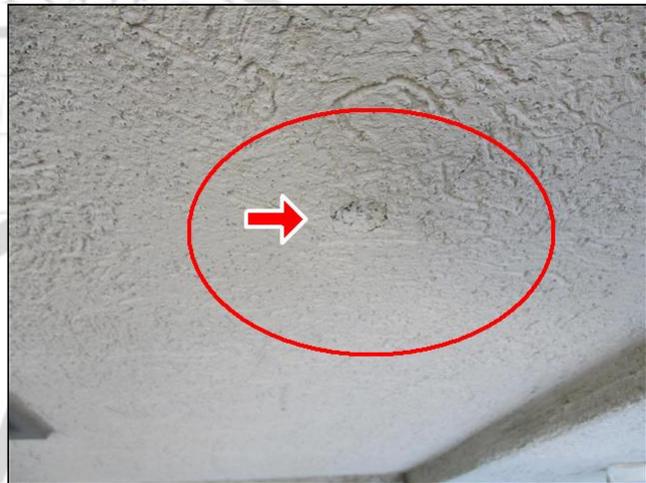
**1.20 (1)** Evidence of EIFS damage was noted at several areas of the home. These areas should be repaired as soon as possible.

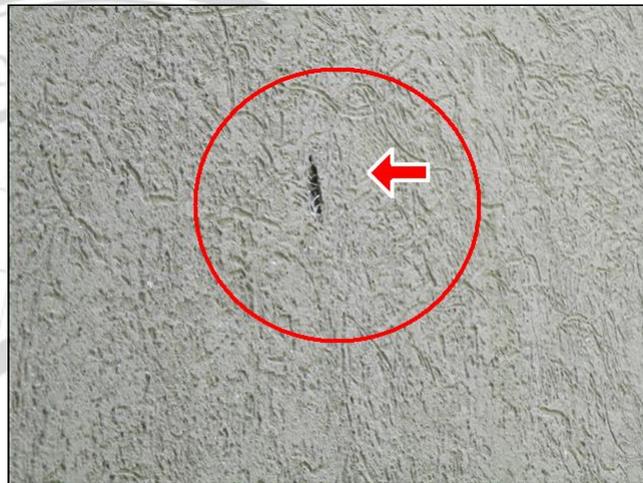
1.20 Item 7(Picture)

**1.20 (3)** There were small areas noted of impact damage. These areas should be properly repaired following EIFS manufacturer's instructions.

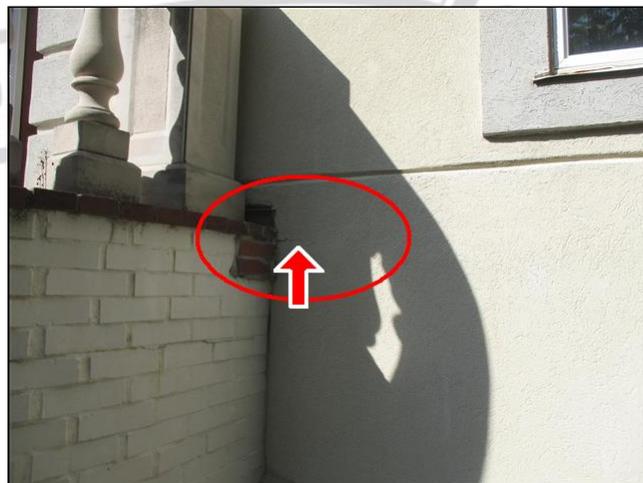
1.21 Item 1(Picture)

**1.21** The EIFS is delaminated where indicated. Repair is needed. This will involve removal or sealing the EIFS at the various locations.

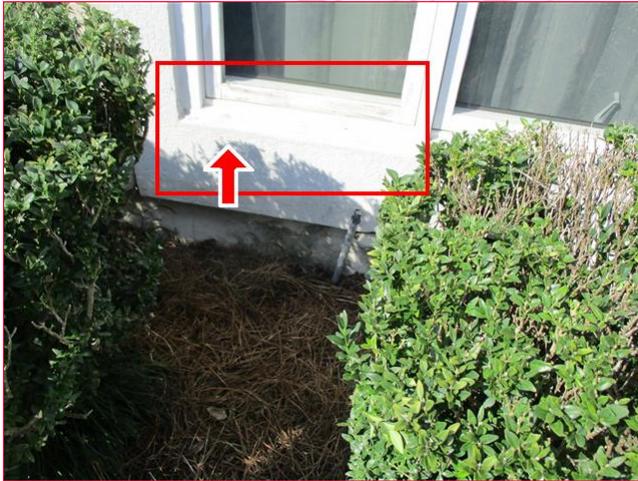
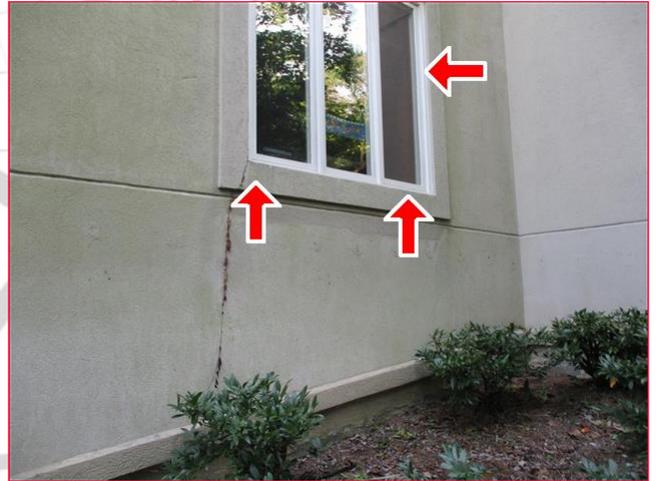
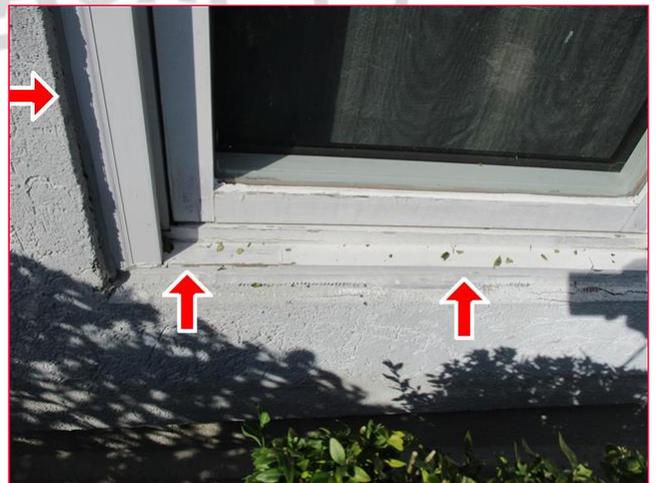
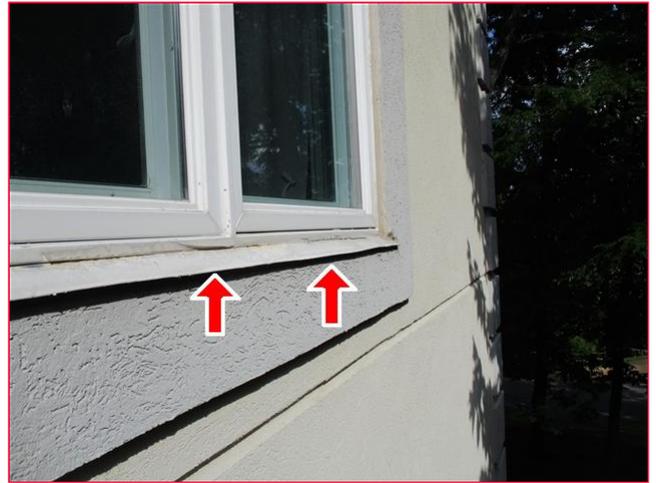
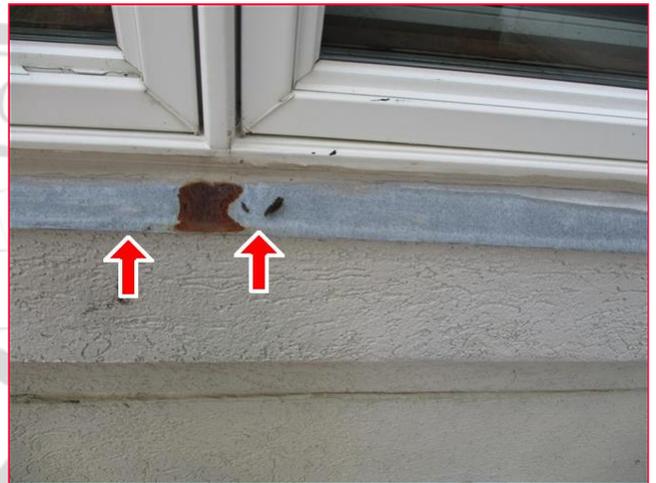
Sealants around windows need repair. This will involve removal of failed sealants, cleaning of the joints and replacement with new sealants (caulks)

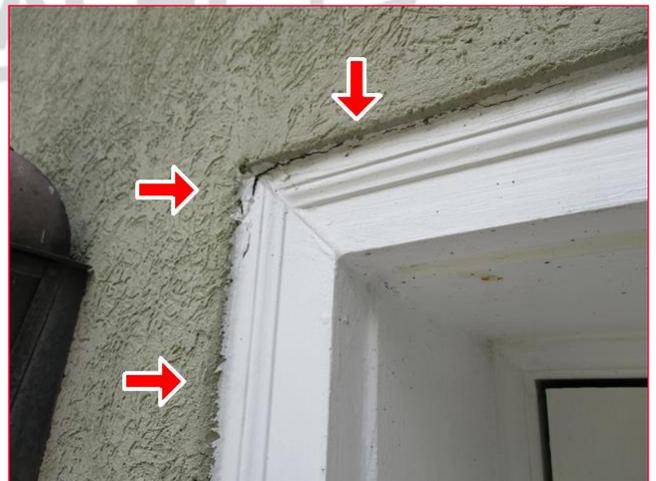
1.4 Item 2(Picture)

Sealant is needed around door frames.

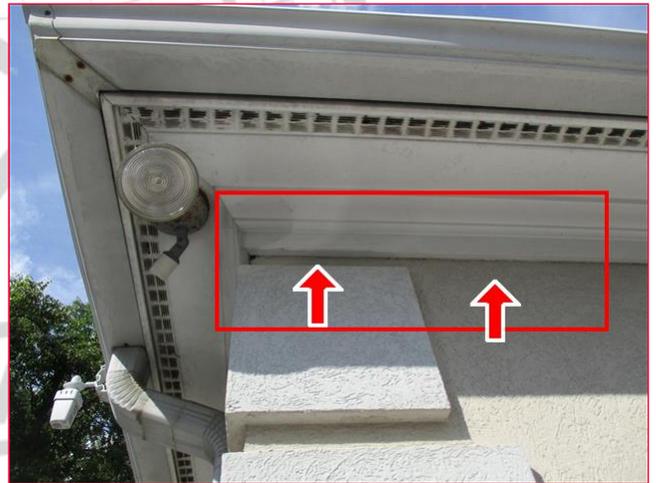
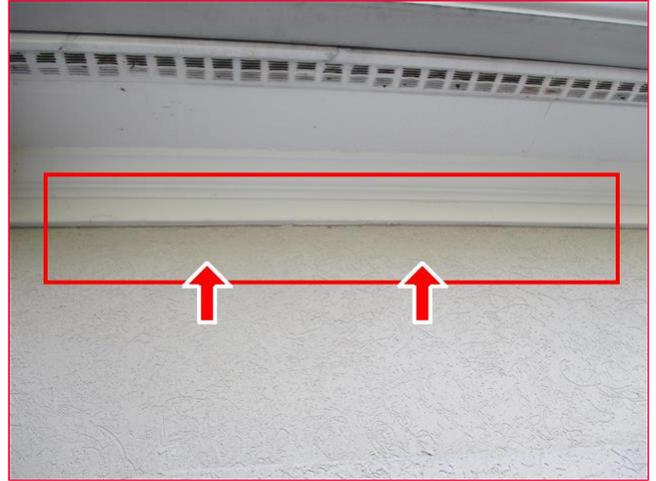
We suggest that areas where the soffit and fascia meet the EIFS/stucco is properly sealed.

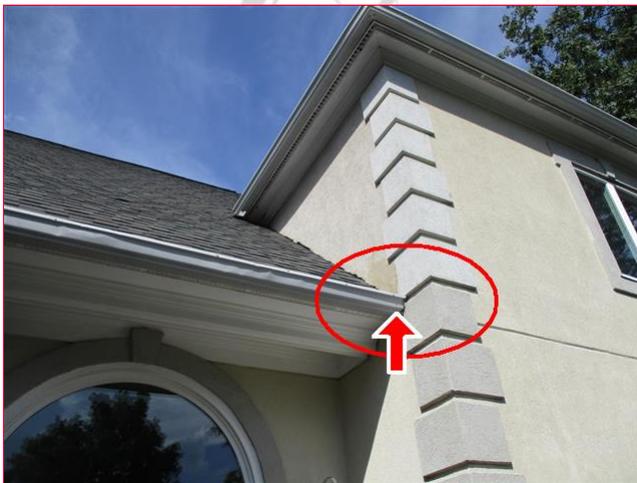
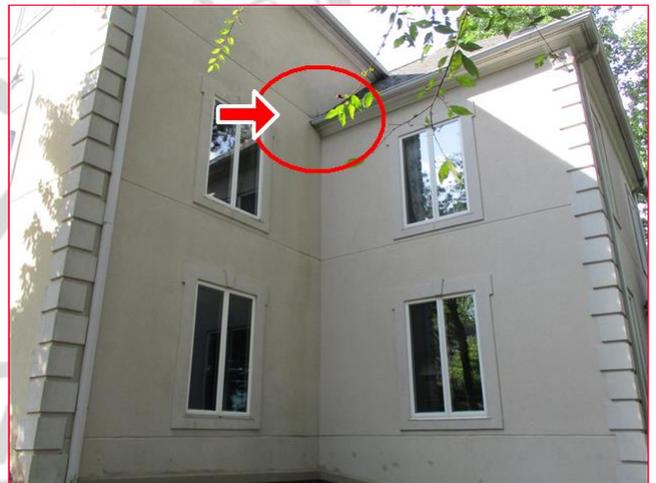
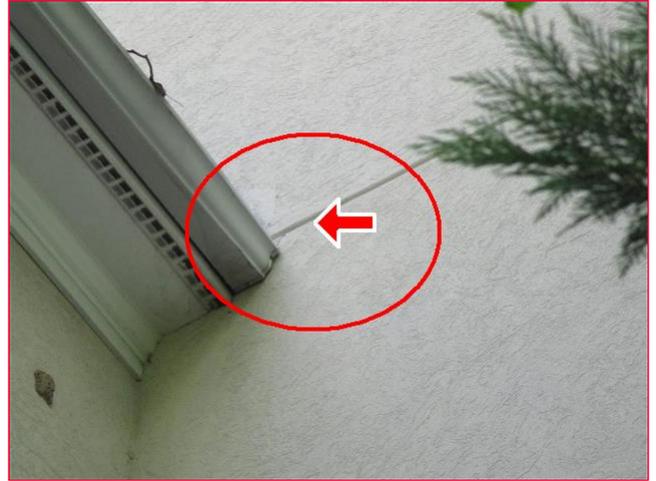
The improper kick-out / roof terminations need to have a proper flashing installed or the current flashing modified or replaced and sealed to prevent water intrusion through the system at these areas. During the installation of any flashing the immediate area can be inspected for wood rot or damage. Any other roof flashing in the area should also be checked as they sometimes can be a contributing cause. We suggest that the sidewall flashings of the roof be set in roof cement in the areas of kickouts as a preventative measures. These areas need to be addressed.

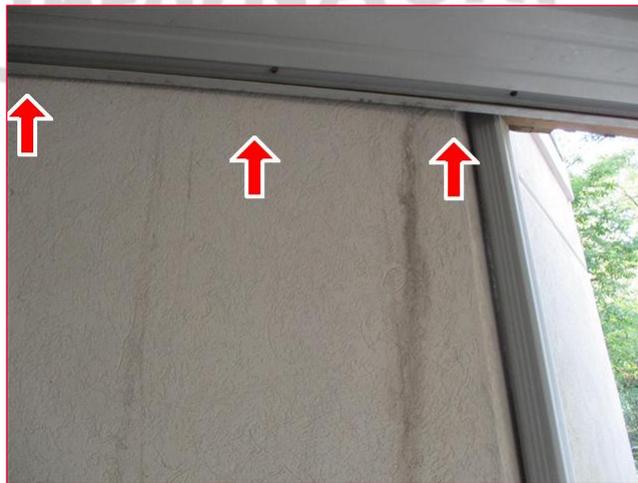
1.8 Item 1(Picture)

The deck installation where it is attached to the house is not done properly. Decks are a very vulnerable area for moisture entry. There is a special flashing configuration that is required for this area.

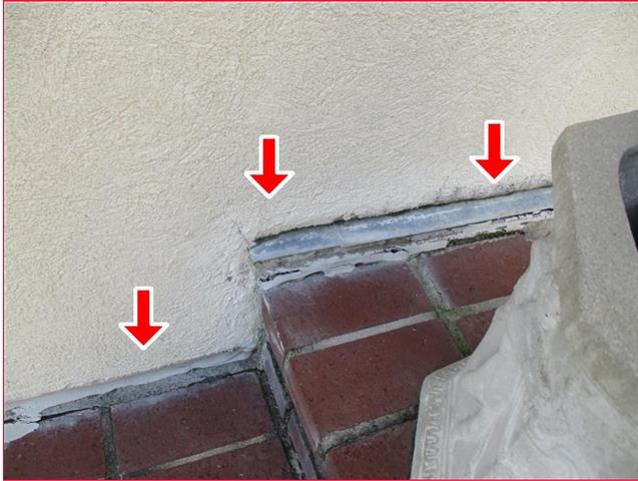
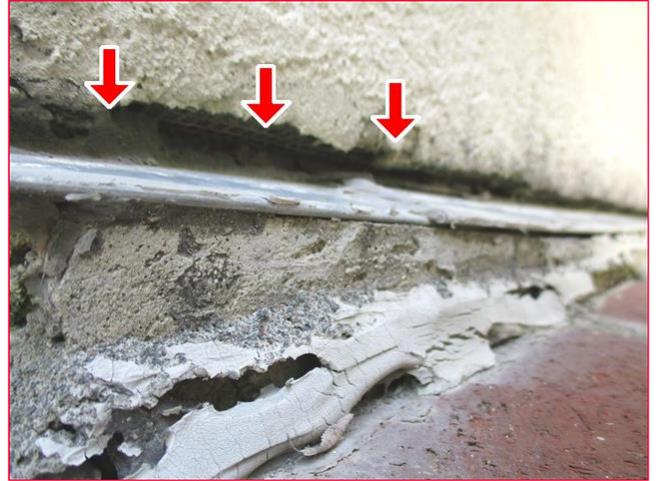
(2) The EIFS should be terminated above the porch or stoop. We can not comment about the condition of the EIFS where it is not exposed. If cutting the EIFS back is not an option, then sealing this joint is necessary.

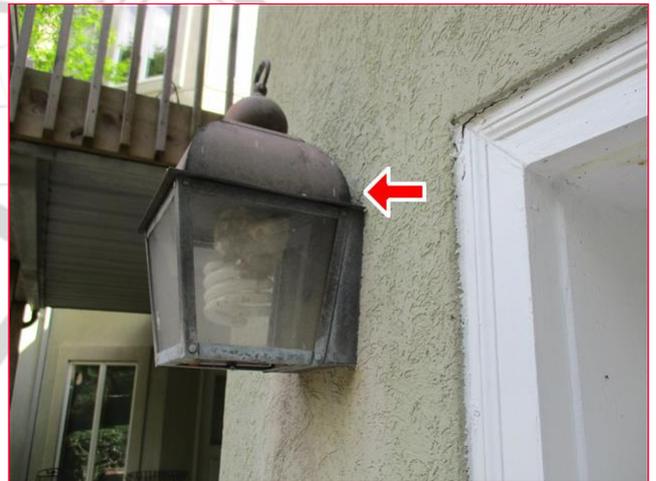
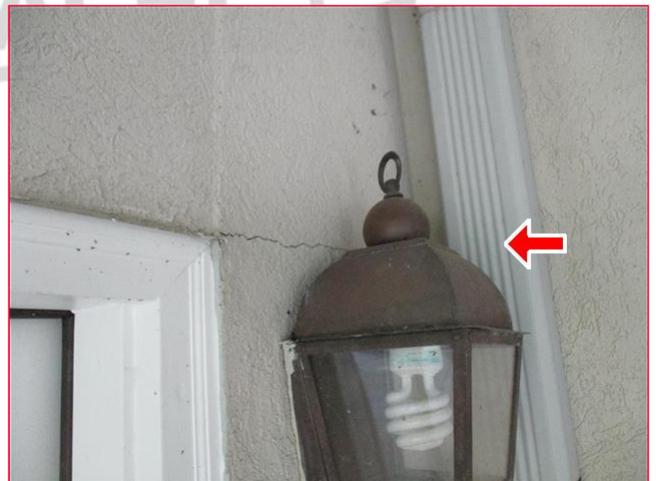
Light fixtures should be sealed to prevent water entry

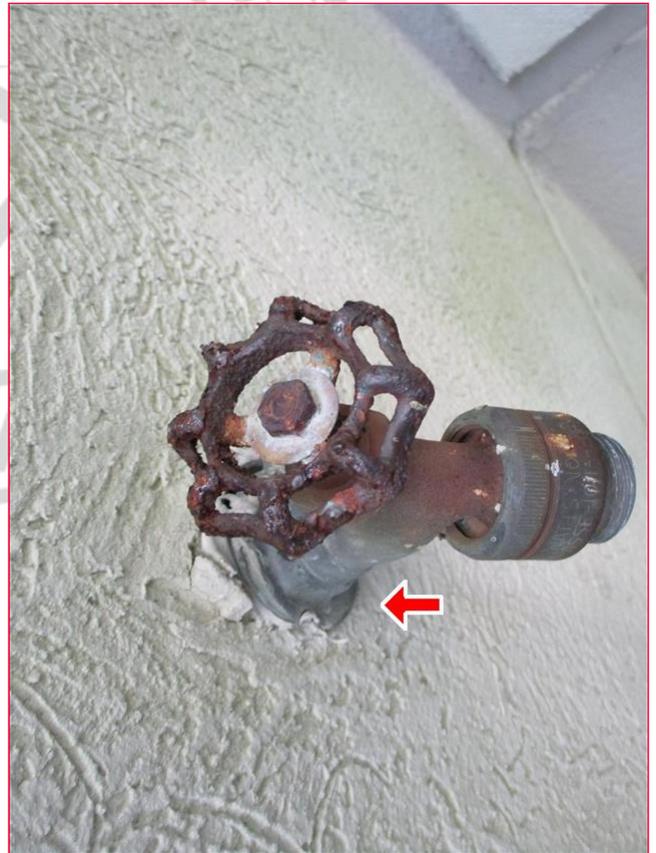
1.12 Item 4(Picture)

- 🏠 Seal all utility penetrations. This includes electric meters, hose faucets, gas pipe penetrations, and electric receptacles.

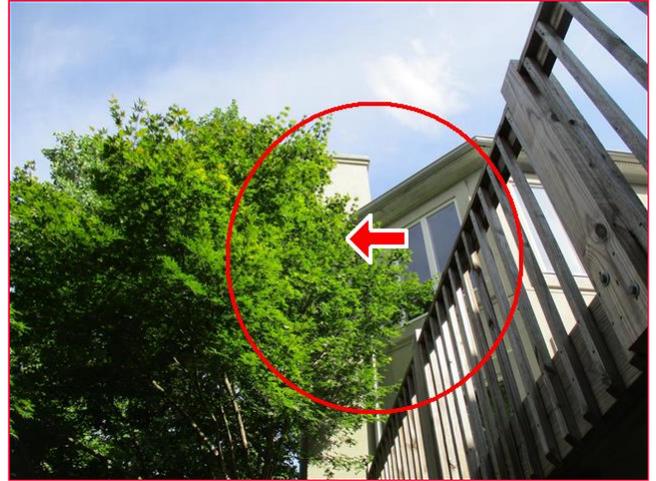
1.13 Item 2(Picture)

- 🏠 Cut vegetation away from home a minimum of two feet.

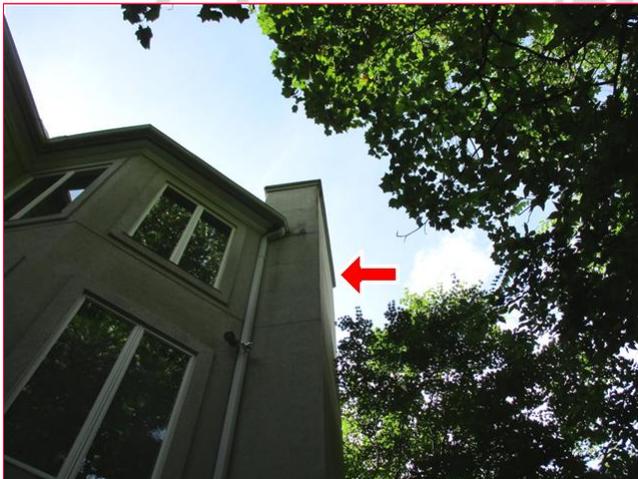
1.15 Item 1(Picture)

Chimney has a hard coat system installed. The system has several large visible cracks that are in need of sealing.

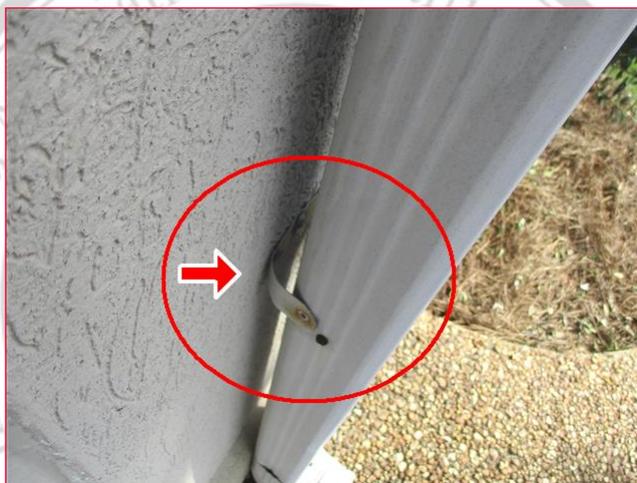
1.17 Item 1(Picture)

The downspout fasteners should be sealed to prevent water entry.

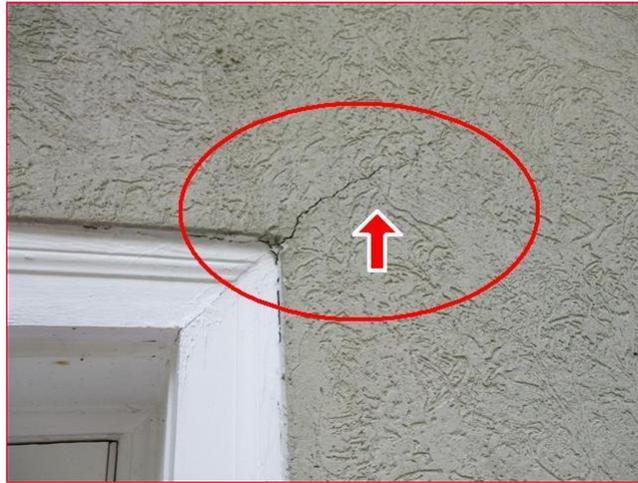
1.18 Item 1(Picture)

There were some cracks found in the system in a few areas - more may be present. These cracks need to be sealed to protect the integrity of the system.

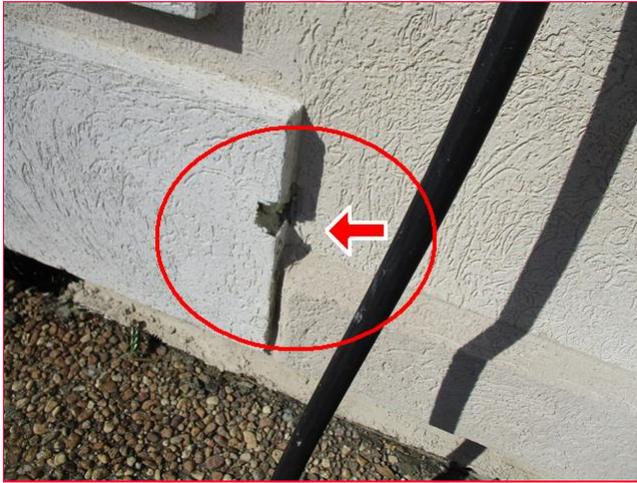
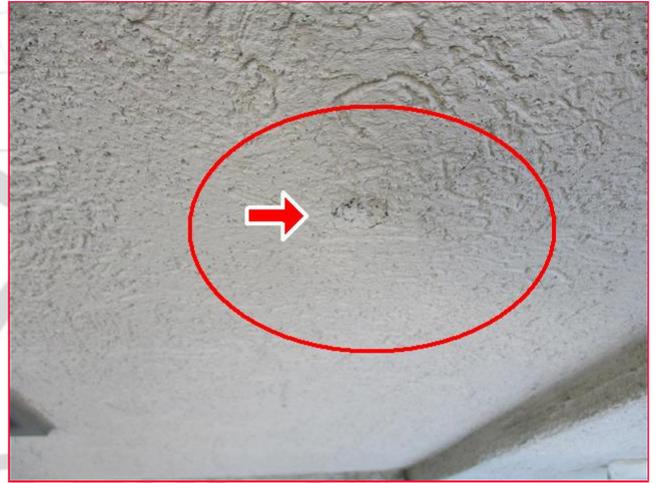
(1) Evidence of EIFS damage was noted at several areas of the home. These areas should be repaired as soon as possible.

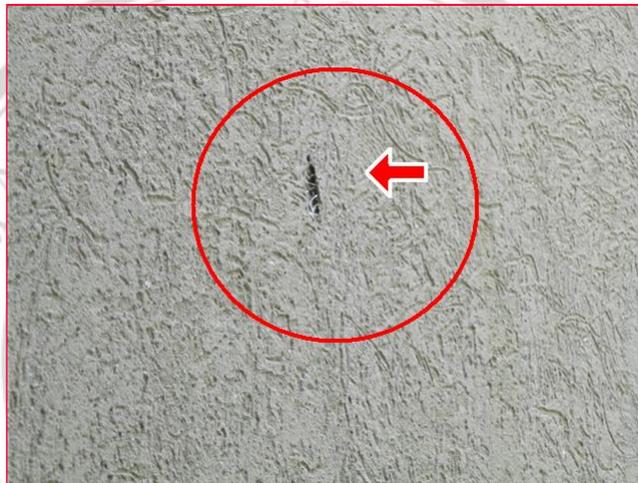
1.20 Item 7(Picture)

(3) There were small areas noted of impact damage. These areas should be properly repaired following EIFS manufacturer's instructions.

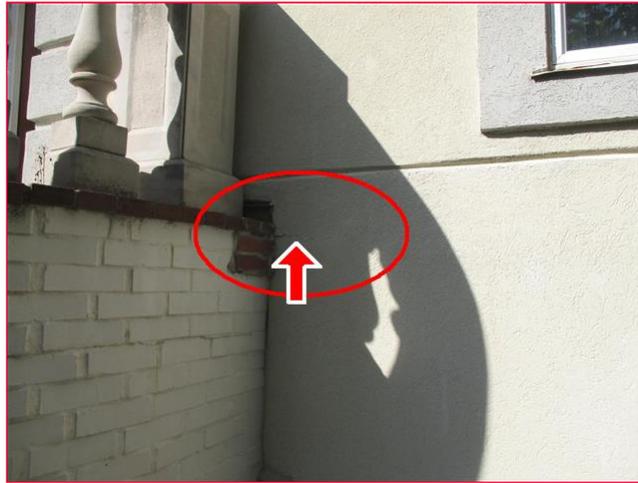
1.21 Item 1(Picture)

The EIFS is delaminated where indicated. Repair is needed. This will involve removal or sealing the EIFS at the various locations.
