**Inspection Report**  
Sample Report

**Specialty Building  
Consultants, LLC**

**Address:** 123 Main St, Birmingham, AL 35080

<b>Date:</b> 8/24/2016	<b>Time:</b> 02:30 PM	<b>Report ID:</b> 08242016-1
<b>Property:</b> 123 Main St Birmingham AL 35080	<b>Customer:</b> Sample Report	<b>Real Estate Professional:</b>

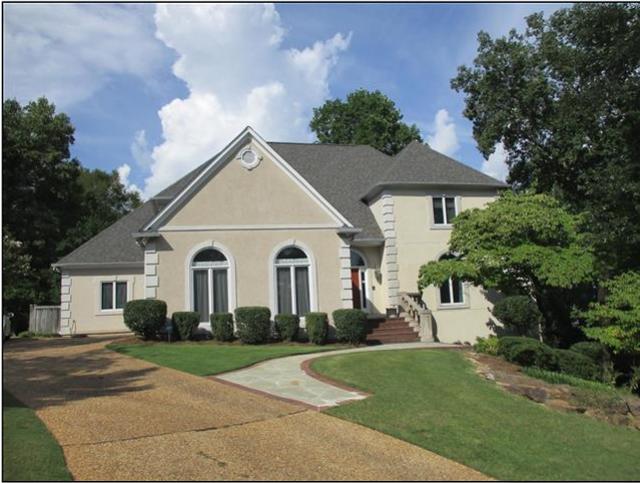
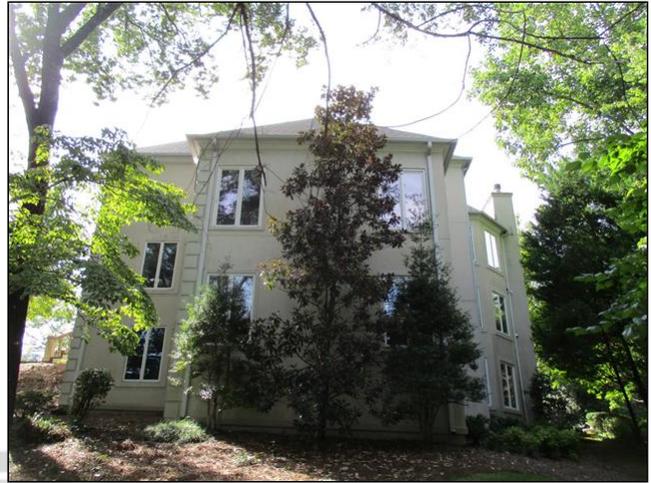
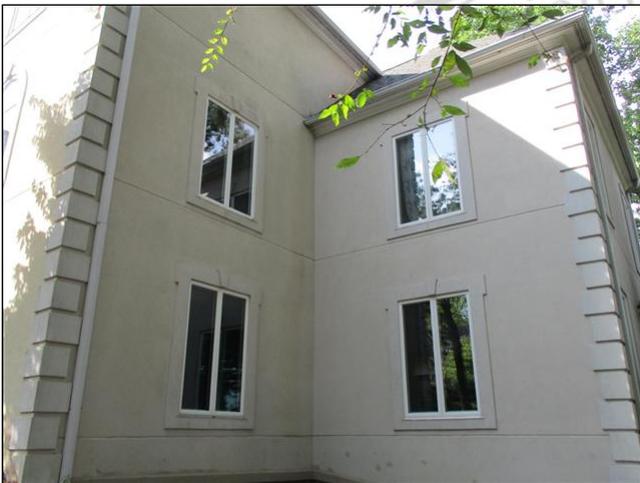
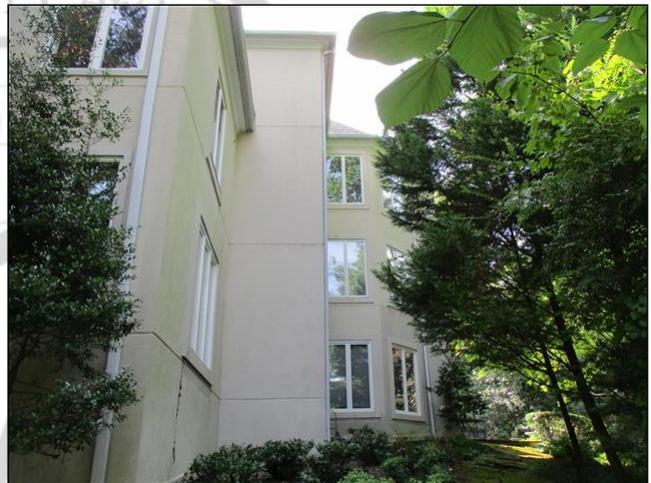
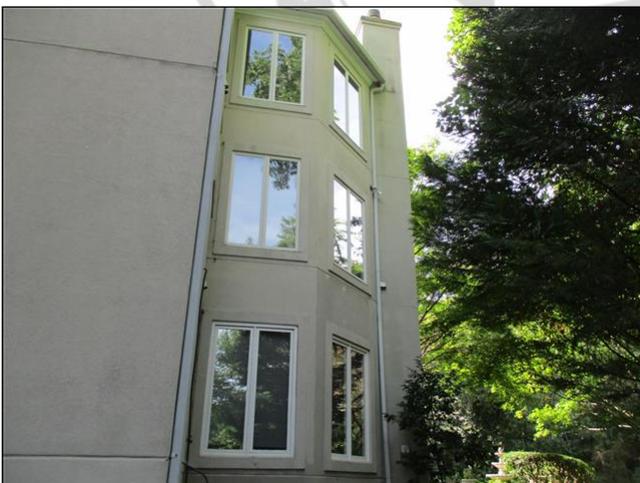
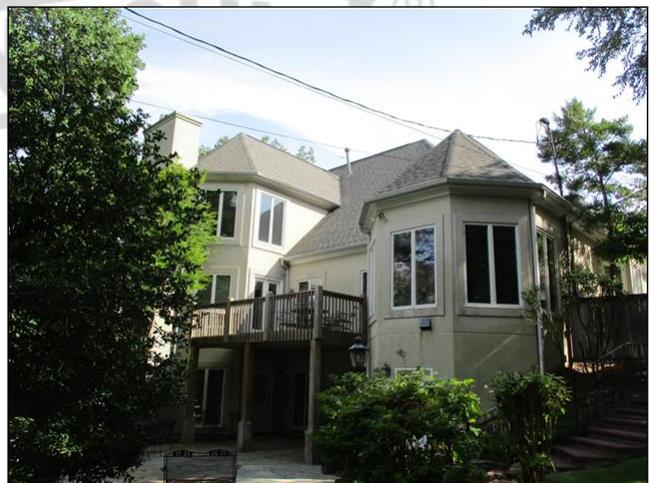
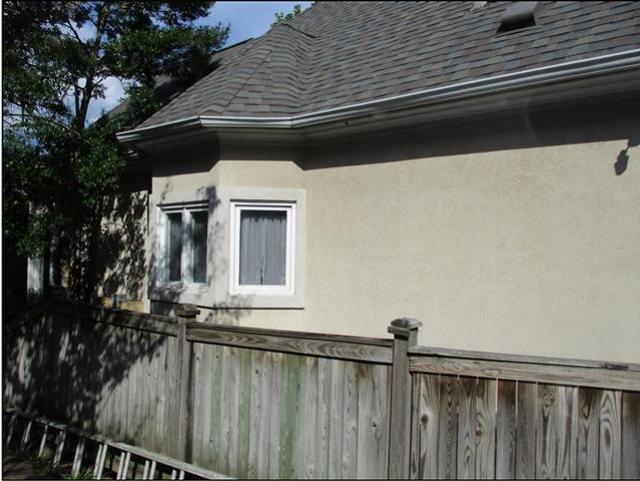
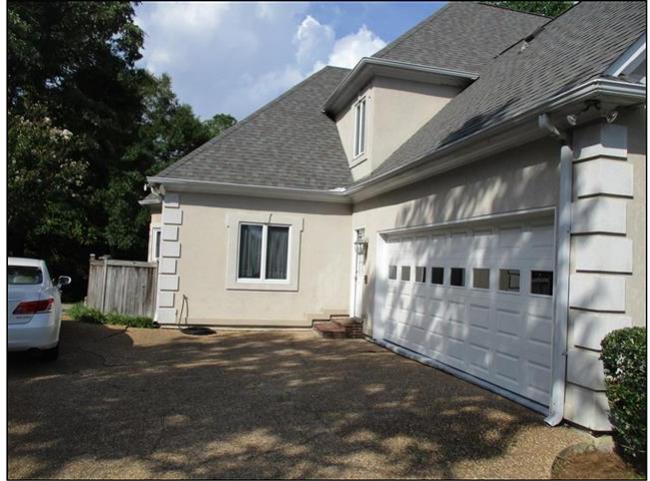
1.0 (1) Elevations

1.0 (2) The finish coat on the front elevation has faded due to the amount of sun the home receives.

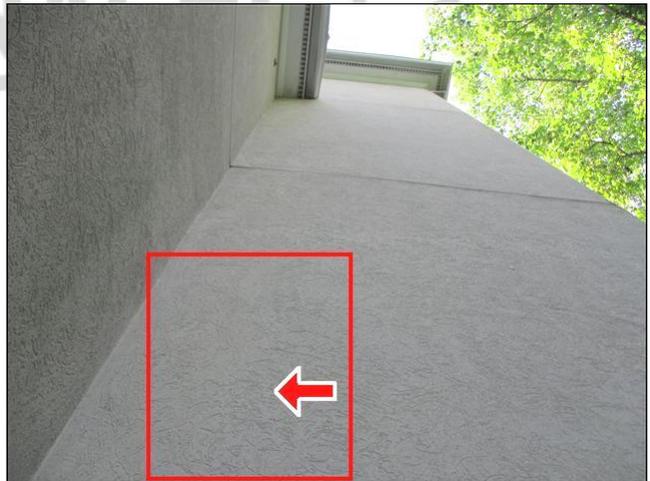
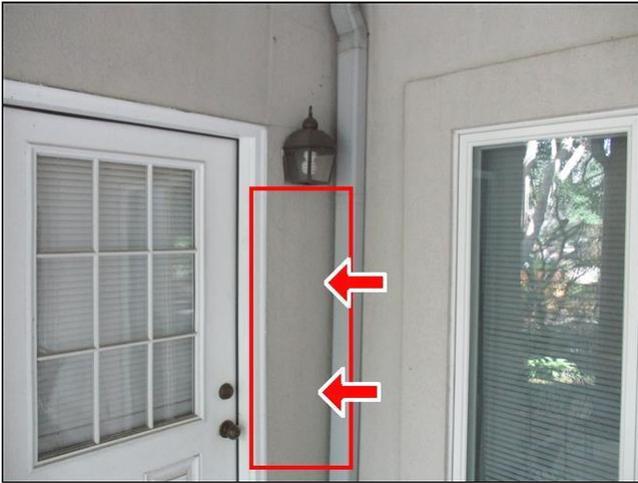
1.1 Inspector recommends taking core samples to verify the integrity of the substrate.

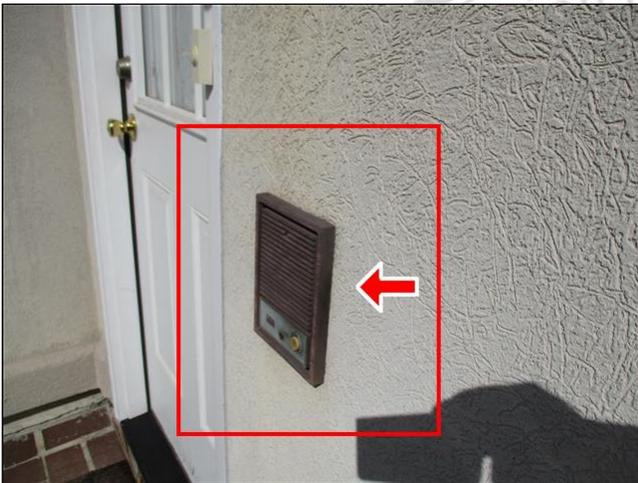
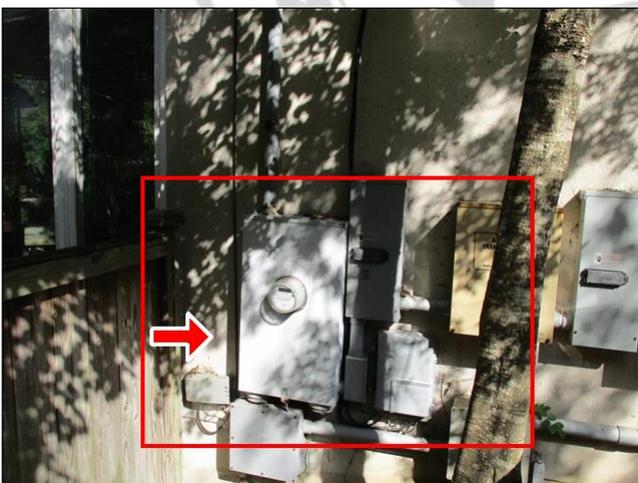
1.2 Seal all areas of dissimilar materials.

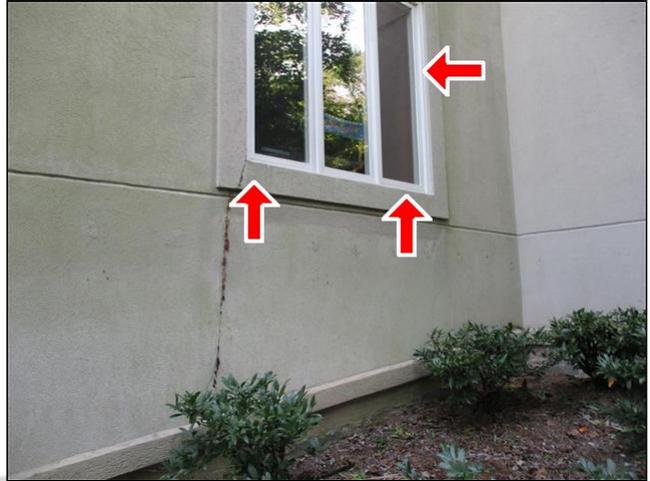
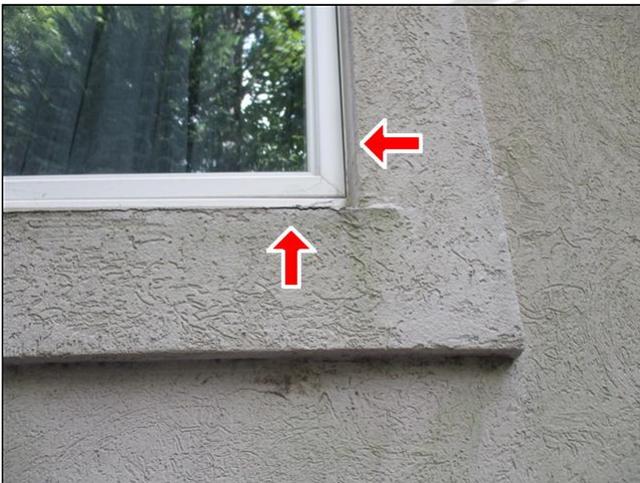
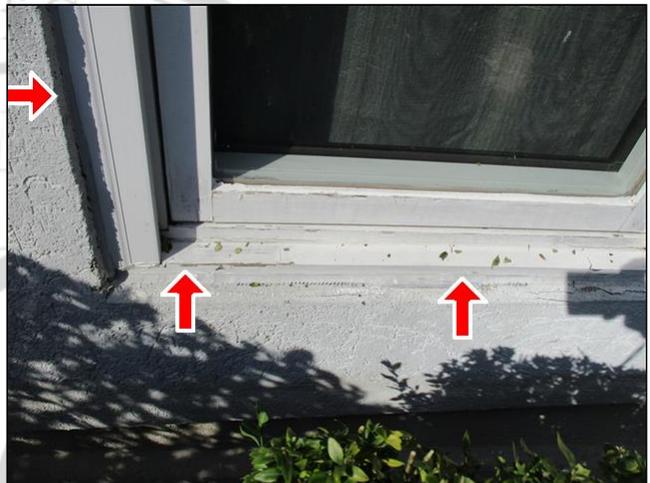
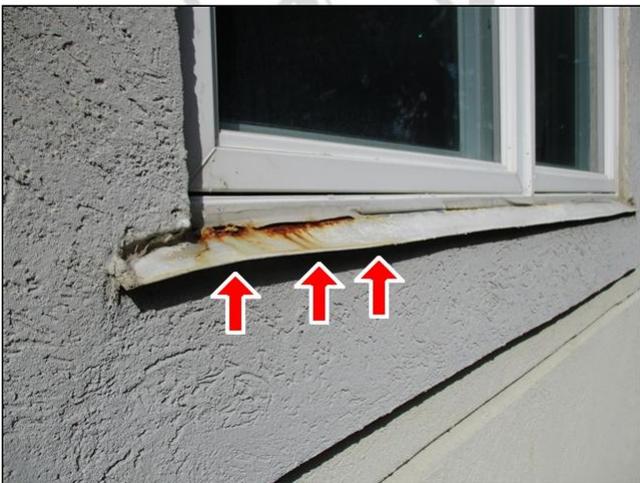
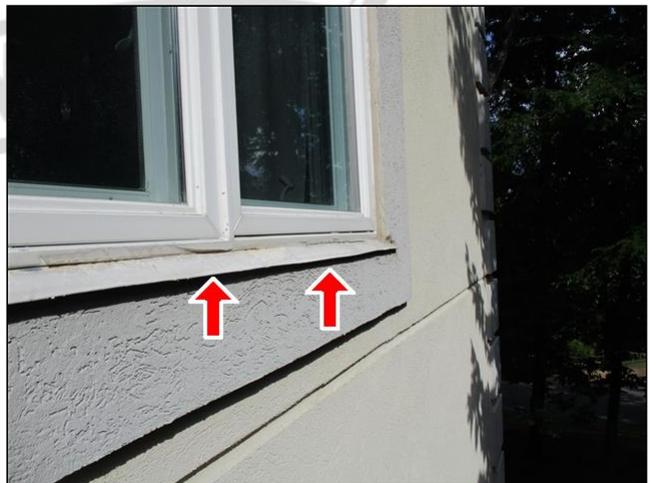
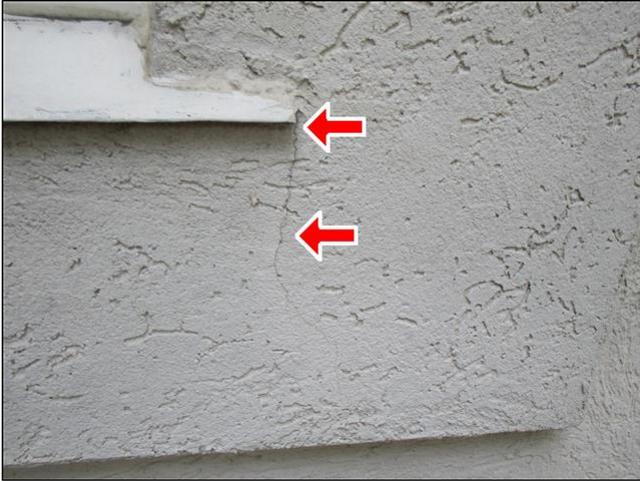
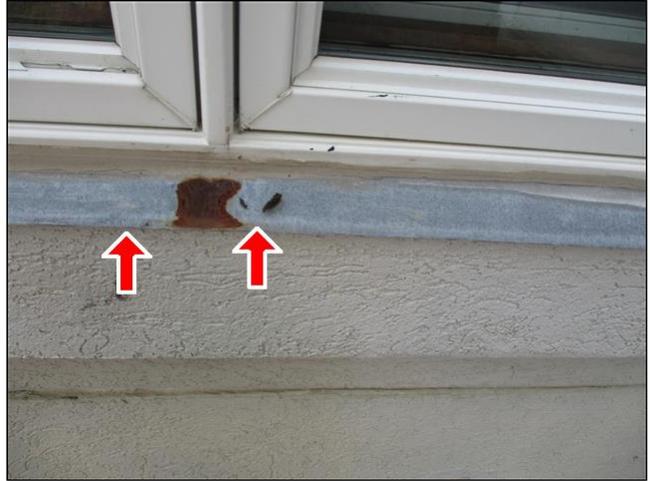
**1.3** Sealants around windows need repair. This will involve removal of failed sealants, cleaning of the joints and replacement with new sealants (caulks)

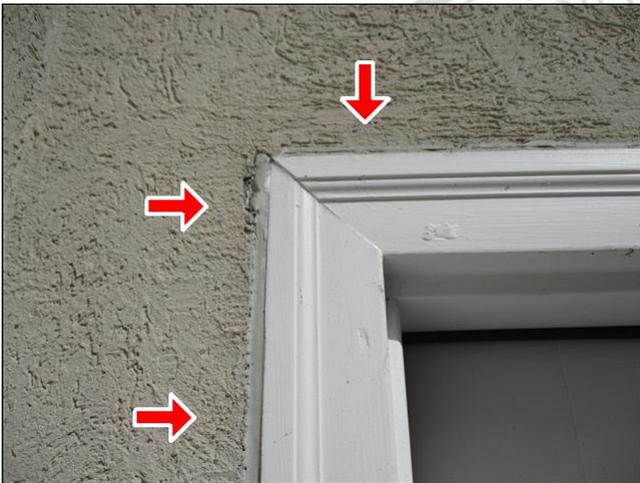
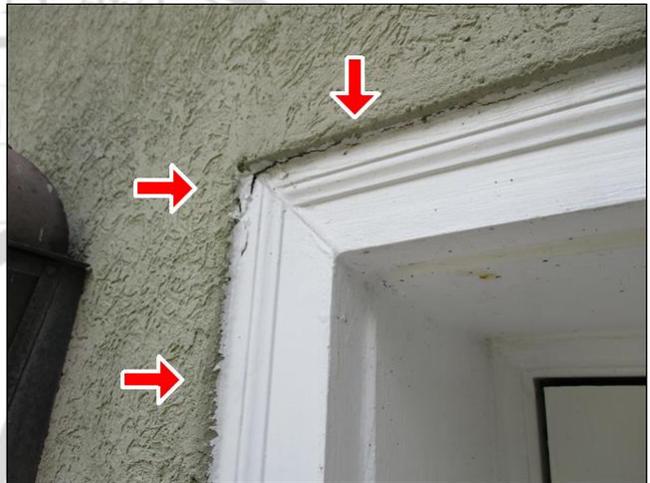
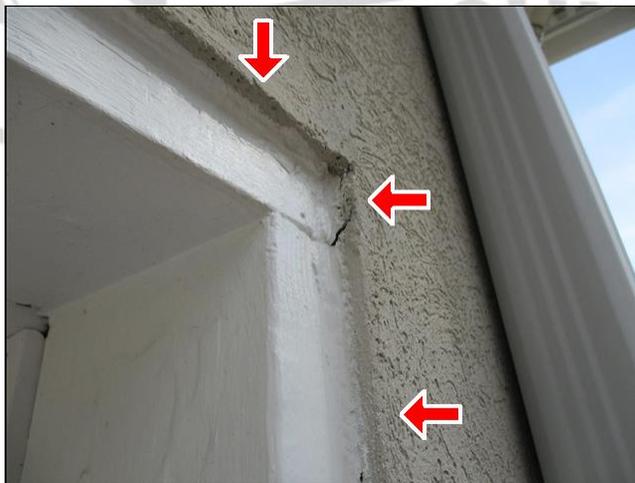
1.4 Sealant is needed around door frames.

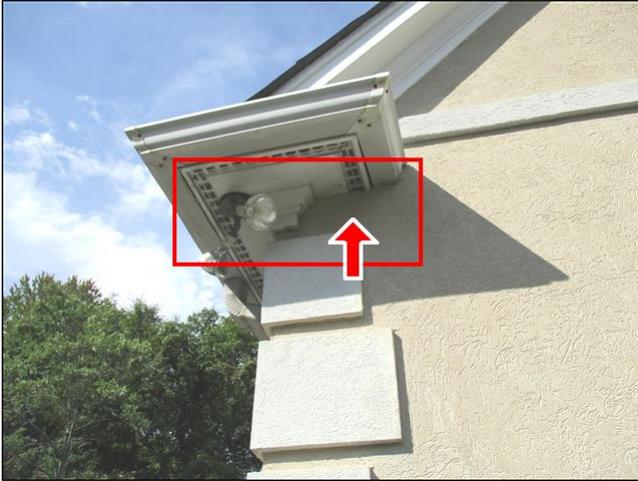
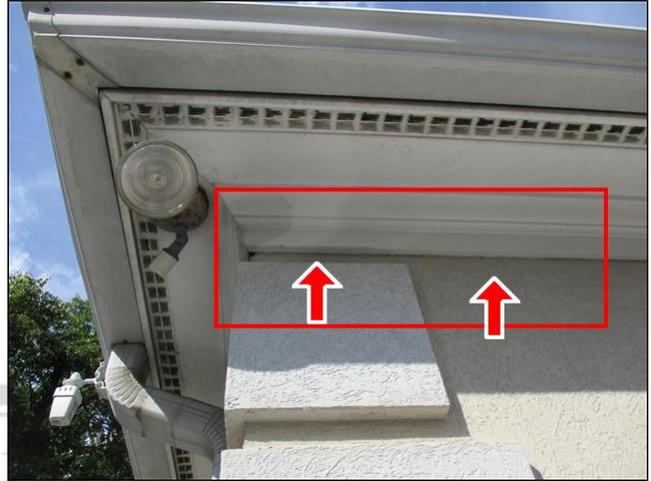
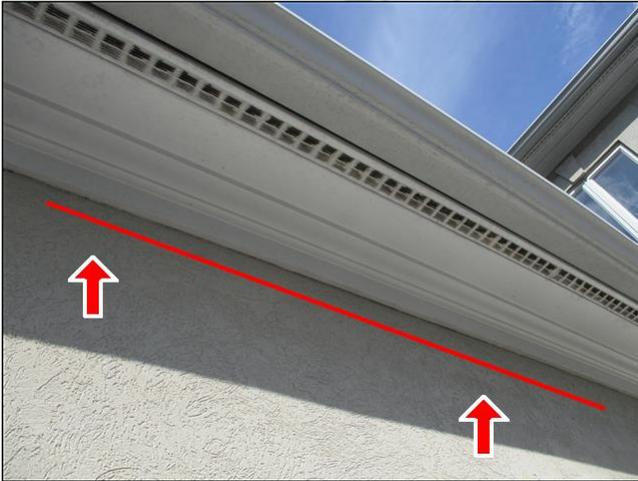
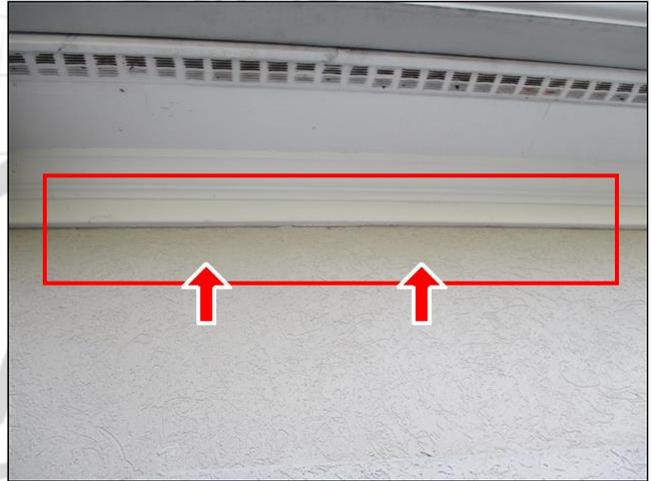
**1.6** We suggest that areas where the soffit and fascia meet the EIFS/stucco is properly sealed.

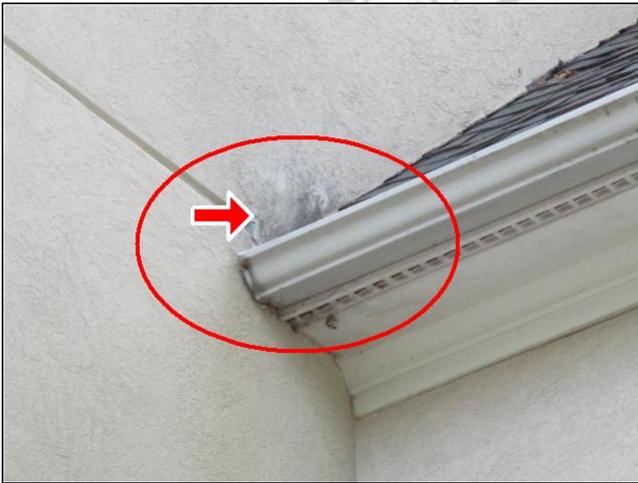
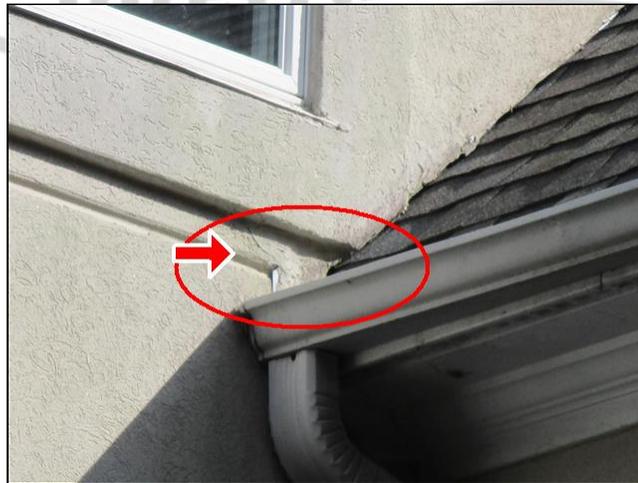
**1.7** The improper kick-out / roof terminations need to have a proper flashing installed or the current flashing modified or replaced and sealed to prevent water intrusion through the system at these areas. During the installation of any flashing the immediate area can be inspected for wood rot or damage. Any other roof flashing in the area should also be checked as they sometimes can be a contributing cause. We suggest that the sidewall flashings of the roof be set in roof cement in the areas of kickouts as a preventative measures. These areas need to be addressed.

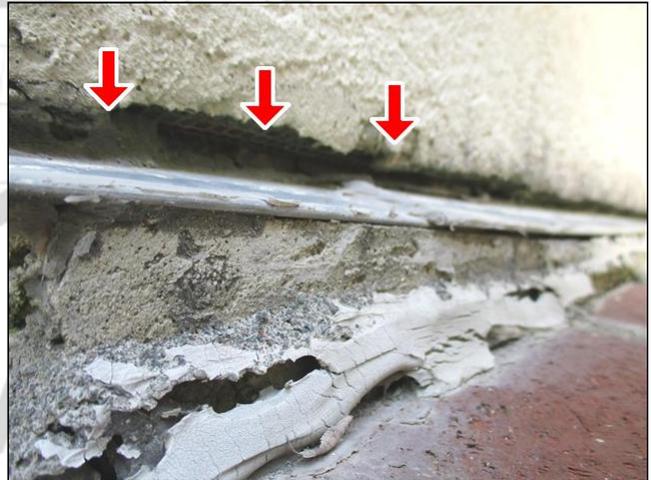
1.9 Item 8(Picture)

**1.9 (2)** The EIFS should be terminated above the porch or stoop. We can not comment about the condition of the EIFS where it is not exposed. If cutting the EIFS back is not an option, then sealing this joint is necessary.

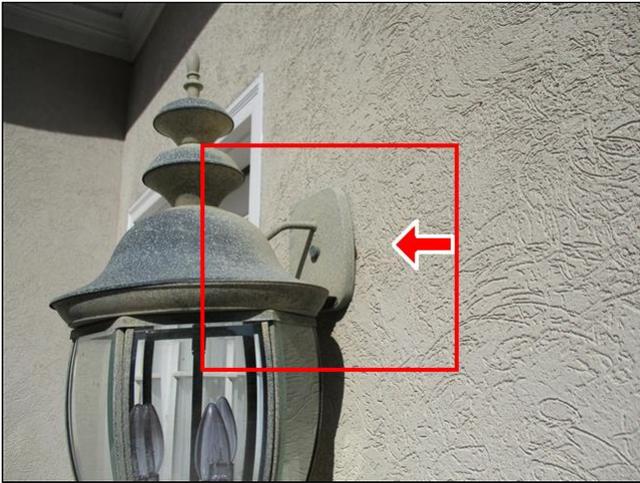
1.10 Item 1(Picture)

**1.10** Light fixtures should be sealed to prevent water entry

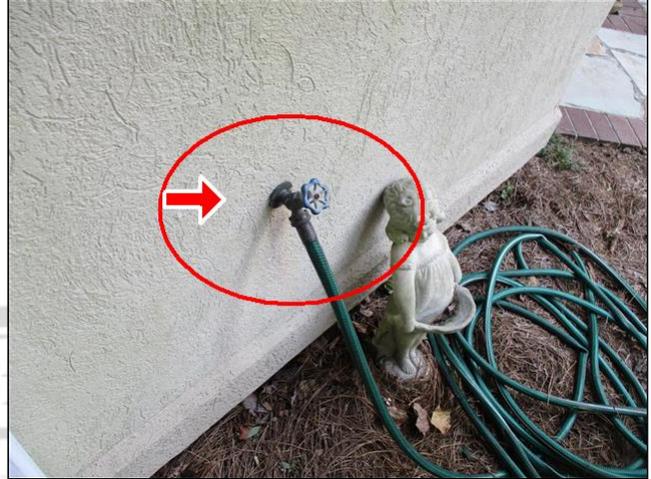
1.12 Item 1(Picture)

**1.12** Seal all utility penetrations. This includes electric meters, hose faucets, gas pipe penetrations, and electric receptacles.

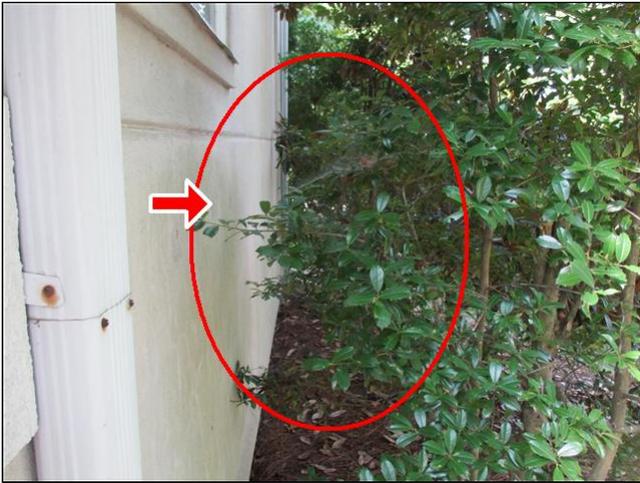
1.13 Item 1(Picture)

**1.13** Cut vegetation away from home a minimum of two feet.

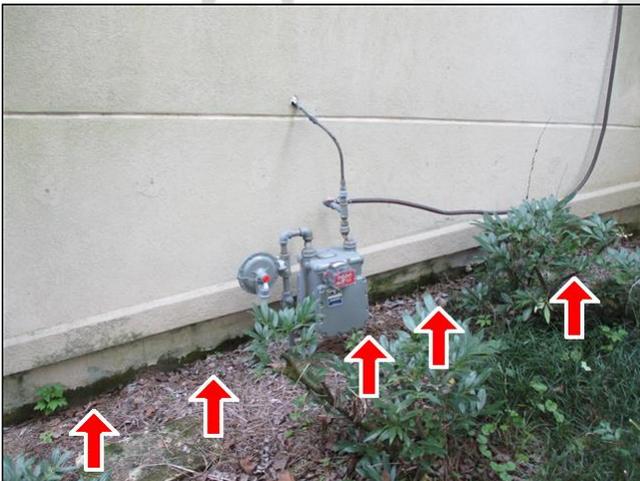
1.14 Item 1(Picture)

**1.14** The EIF system does terminate above grade.

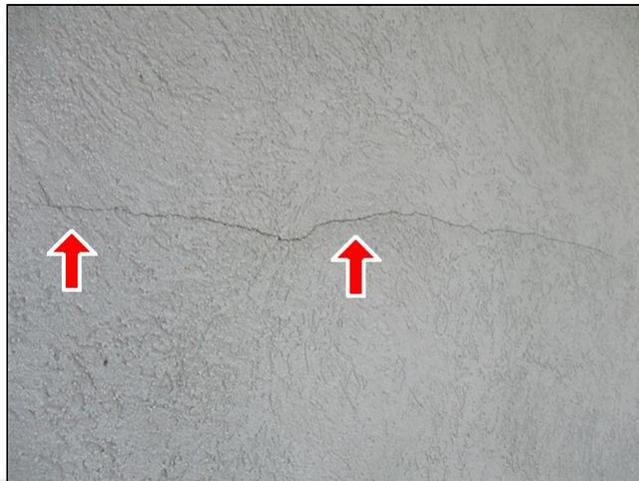
1.15 Item 2(Picture)

**1.15** Chimney has a hard coat system installed. The system has several large visible cracks that are in need of sealing.

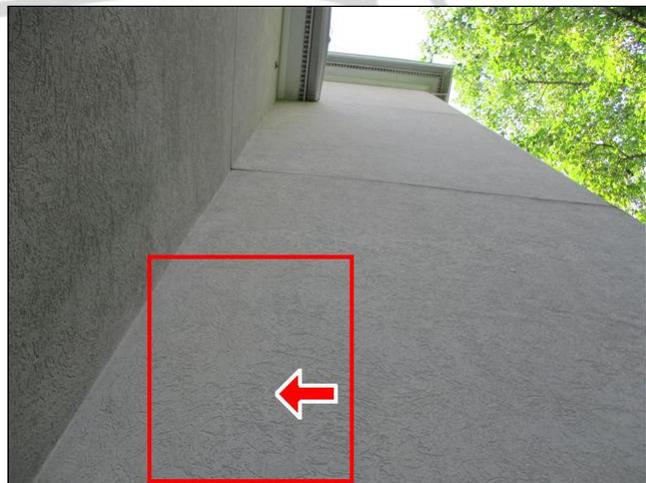
1.20 Item 4(Picture)

**1.20 (1)** Evidence of EIFS damage was noted at several areas of the home. These areas should be repaired as soon as possible.

**1.20 (2)** Inspector recommends taking core samples to verify the integrity of the substrate.

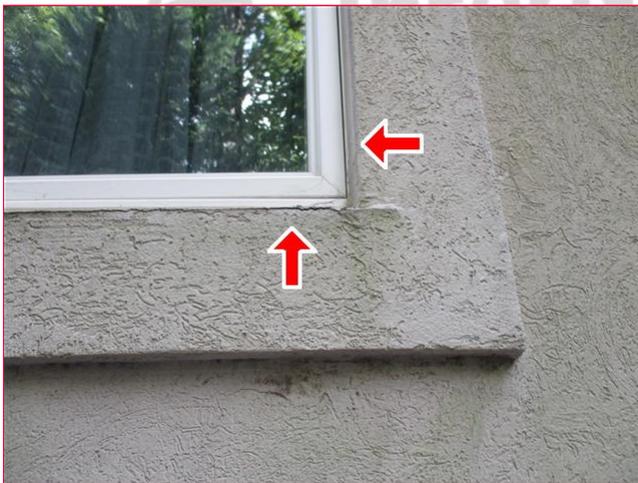
1.3 Item 3(Picture)

Sealants around windows need repair. This will involve removal of failed sealants, cleaning of the joints and replacement with new sealants (caulks)

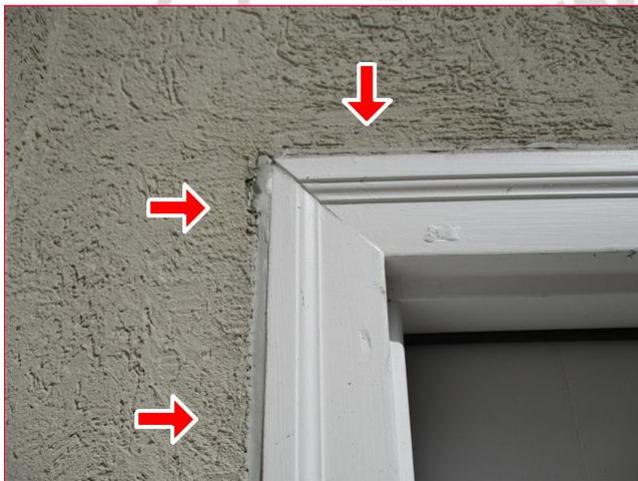
1.4 Item 1(Picture)

Sealant is needed around door frames.

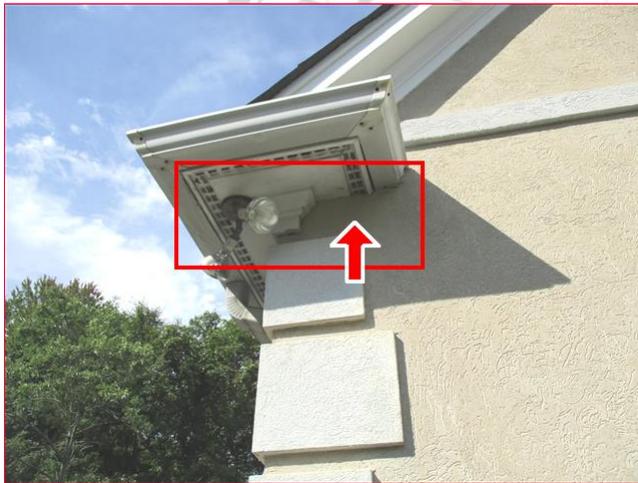
1.6 Item 1(Picture)

We suggest that areas where the soffit and fascia meet the EIFS/stucco is properly sealed.

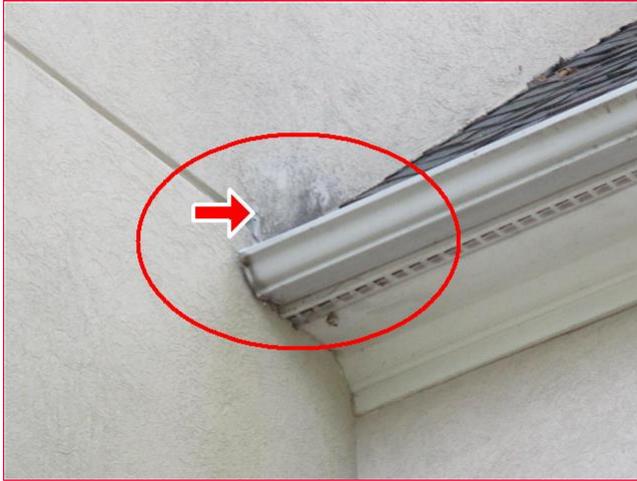
1.7 Item 3(Picture)

The improper kick-out / roof terminations need to have a proper flashing installed or the current flashing modified or replaced and sealed to prevent water intrusion through the system at these areas. During the installation of any flashing the immediate area can be inspected for wood rot or damage. Any other roof flashing in the area should also be checked as they sometimes can be a contributing cause. We suggest that the sidewall flashings of the roof be set in roof cement in the areas of kickouts as a preventative measures. These areas need to be addressed.

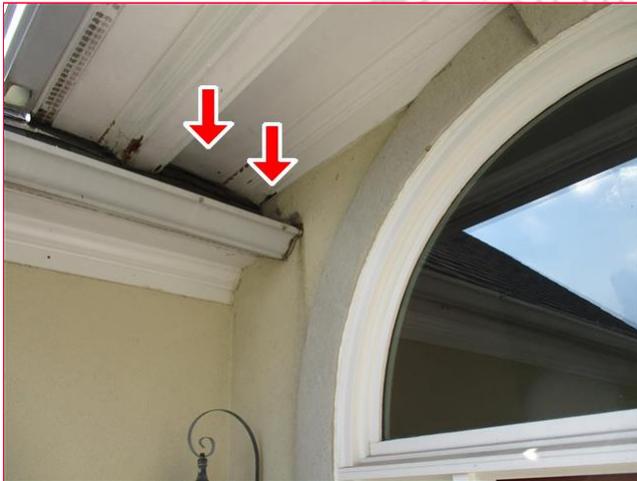
1.9 Item 3(Picture)

(1) The EIFS should be terminated above the porch or stoop. We can not comment about the condition of the EIFS where it is not exposed. If cutting the EIFS back is not an option, then sealing this joint is necessary.

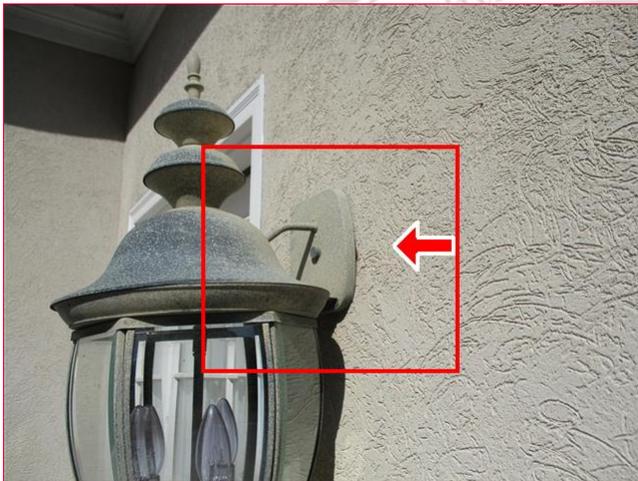
1.10 Item 1(Picture)

Light fixtures should be sealed to prevent water entry

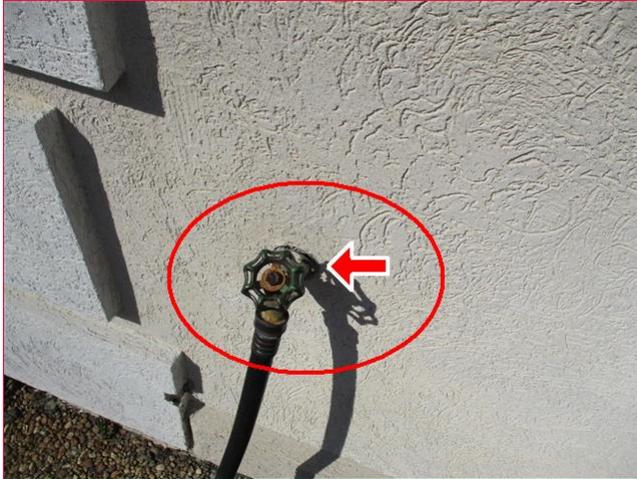
1.12 Item 1(Picture)

- 🏠 Seal all utility penetrations. This includes electric meters, hose faucets, gas pipe penetrations, and electric receptacles.

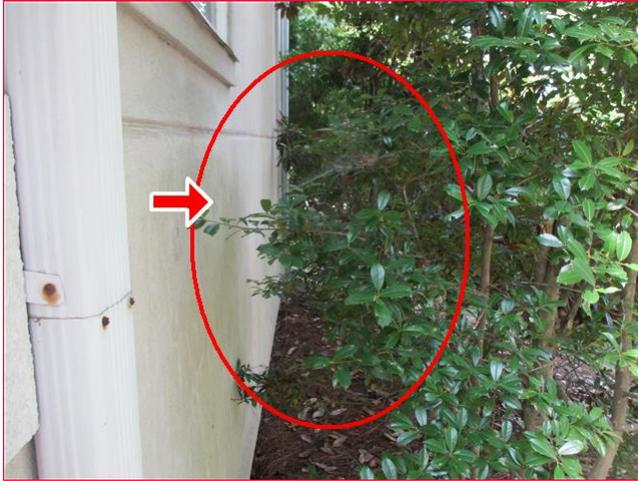
1.13 Item 1(Picture)

- 🏠 Cut vegetation away from home a minimum of two feet.

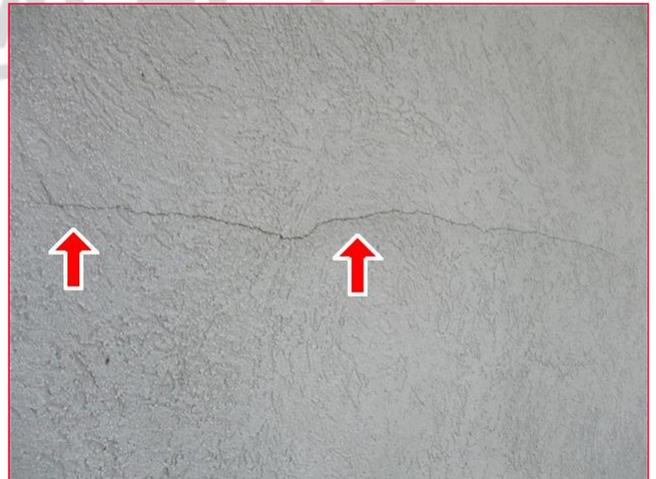
1.15 Item 2(Picture)

Chimney has a hard coat system installed. The system has several large visible cracks that are in need of sealing.

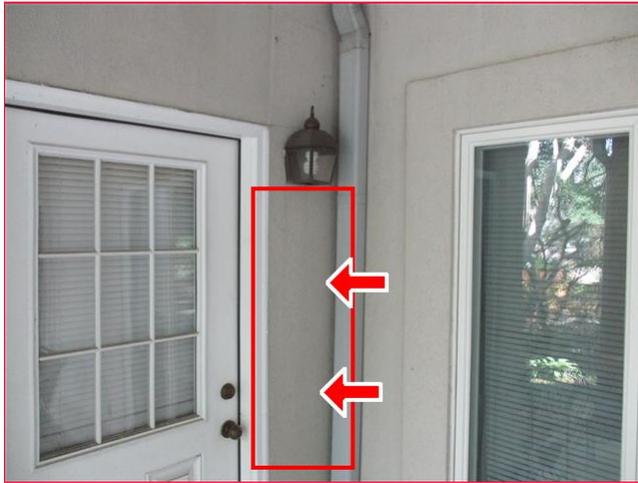
1.20 Item 5(Picture)

(1) Evidence of EIFS damage was noted at several areas of the home. These areas should be repaired as soon as possible.

(2) Inspector recommends taking core samples to verify the integrity of the substrate.
